Historic Structure Report

June 2002

**Bodie Island Lighthouse
at
Cape Hatteras National Seashore
North Carolina**

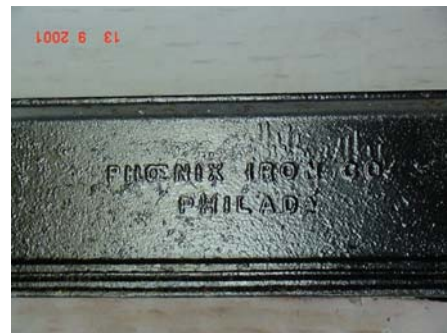
Landing support beams in Tower.
Beams were actually installed with
manufacturer's stamp upside down.
Photo courtesy of Jack McCombs

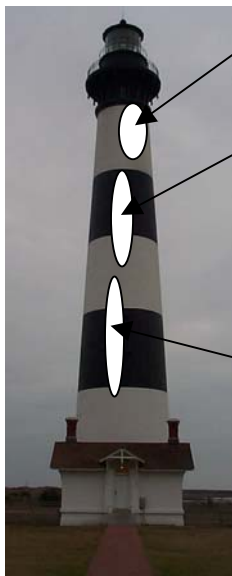
- What appeared as a dark stain or moisture was observed in this area. It was difficult to view this condition, but the condition was sufficiently noticeable to merit recording.
- Stain or dampness in band three vertically aligned with the north corner of the window in band 4 and extended to that point. It had rained earlier in the day that these visual observations were made; therefore, the “stain or dampness” may have been of little or no significance. However, given the other observations made on this and other elevations of the Tower, it is worth noting and monitoring.
- What appears to be efflorescence on bands 1 and 2 to the north of the window in band 2.
- A small spall area was observed at the area of the upper south corner of the window in black band 2. While not major, this observation suggests the likelihood of some moisture behind the brick in isolated areas.

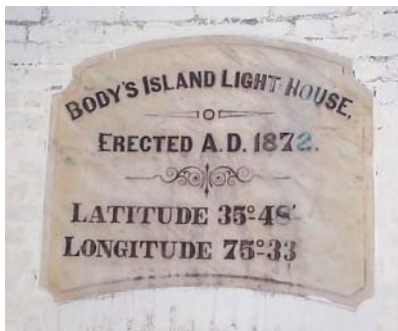
Dedication Plaque: A marble dedication plaque is mounted on the archway facing the center of the Tower. (See photo). There are three points of note regarding this plaque. First, the spelling of "Body" is an early spelling of the name, thus suggesting an early fabrication and installation of the plaque. The second point of note is that the 1871 construction documents do not show a plaque, suggesting one was designed, fabricated, and installed in an exercise separate from the original construction. Thirdly, this

is not the first plaque erected. The original plaque listed the members of the Lighthouse Board and the date at the time the construction of the Bodie Island Lighthouse was begun. An image of the drawing for the original plaque is found in the Chronology of Development and Use portion of this report. The drawing indicates that the location of this plaque is also the location of the installation of the first plaque. The current plaque is in excellent condition, but has some overpainting of white, the result of applications of paint to the wall to which it is affixed, that should be removed.

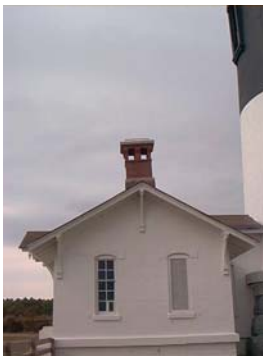
The southern chimney, above the Oil Room, has a noticeable lean to it above the roofline. Concern has been expressed that the chimney may be unstable. However, there is no apparent evidence of distress to the brickwork. Historic photographs from the 1890s suggest that this chimney was leaning at that time, implying that the chimney may have been originally built out of plumb. The tilt has had no apparent adverse effects on the structural integrity of the chimney. Therefore, recommendations in this report do not include rebuilding or straightening of the chimney.

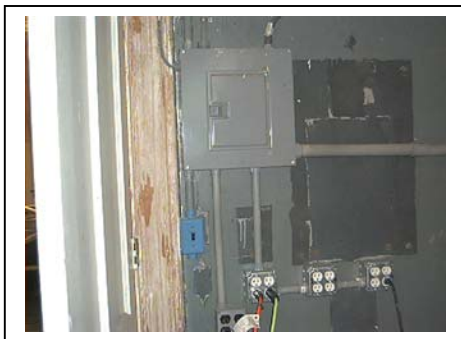
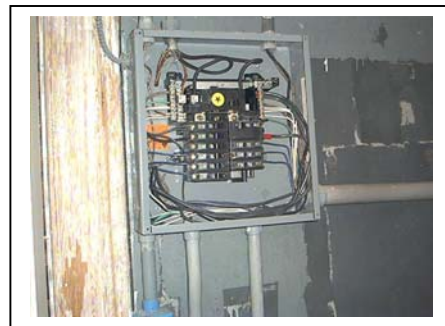
The distribution panel is a 12-circuit panel with a 100A main circuit breaker located in the north wall of the Oil Room (see photos 7 and 8).

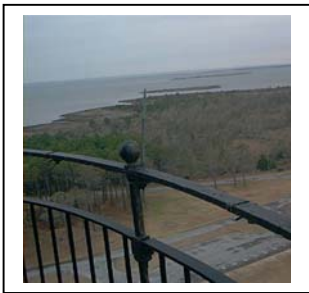
Photo 9

There are number of lightning rods installed on the handrail of the gallery and supported by the handrail (see photo 9) with two opposite down conductors (2/0) on the north and south side of the Lighthouse. The two down conductors are bare copper and are routed exposed to approximately 14' above ground, then routed to a ½" schedule 40 PVC conduit to the earth (see photos 10 and 11). There was no indication of what the down conductors were connected to underground (ground rods, ground ring, or both). The original lightning rod at the top of the ventilator ball is no longer connected to any down conductors. However, a bare copper cable runs from a newell post at the base of the Tower stairs, along the perimeter of the ground floor of the Tower, through the window on the north side of the Hall Connection (H/100), and down the wall on the exterior into the ground. This may be part of the cable installed in 1884 to replace the original lightning protection system. It is not known if this cable is attached to any ground plate or grid underground. It is, however, attached to the bottom newel post of the stairs. This is a safety concern. If it is connected to nothing underground, the possibility exists for a lightning strike to electrify the stairs and landings, which could cause injury to anyone standing on or touching them at the time. If it is desired to retain this feature because of possible historic value, a connection to an underground grounding grid should be verified or made, or the cable should be disconnected from the stairway and secured so that it will not touch the stairs or any other metal. Otherwise, it should be removed.

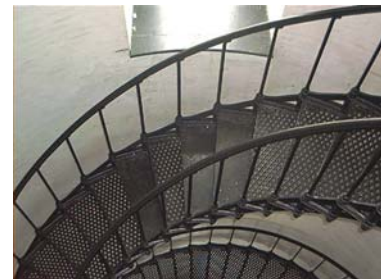
Another safety concern has been the possibility of visitors falling out of windows. While on the stairs, it would be very difficult for visitors to “fall” out of the windows, as this would generally require climbing over the stair railing and standing on the window stool to accomplish. At the 8th level, however, it might be possible for visitors to get close enough to a window to fall out. Currently, the windows are painted shut or are

not operable. However, should the National Park Service follow the recommendations found later in this report to ventilate the Tower by opening the windows, fall protection should be installed to prevent visitors from tumbling out in attempts to see out or to get a photograph from high in the Tower. This fall protection could be something as simple as a bar installed across the window opening at about 4' from the floor to remind visitors not to access the window stool or something more substantial, such as a barred grille, across the lower part of the window. Either such device should be too close to the bottom of the window to allow a visitor to crawl between it and the window stool, and too high for the visitor to climb over.

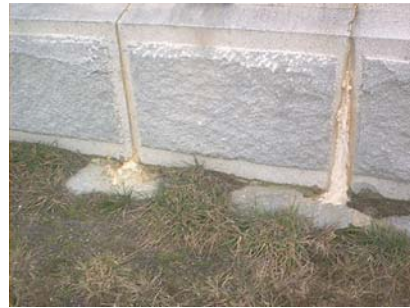
The stone foundation and brick walls of the exterior of the Tower do not appear to be in distress. Leaching of the mortar from the foundation, likely caused by rising damp, is not sufficient to jeopardize the stability of the structure. Cleaning of the exterior joints and repointing will be required periodically, as it would on any stone or brick structure, and should be performed at this time with a mortar appropriate to the existing mortar. However, a closer inspection of the brick Tower, especially of the upper levels, should be performed to document that cracks appearing in the interior of the Tower do not penetrate to the exterior. Like the Oil House, the paint of the Tower contains lead. The paint on the exterior of the Tower should be removed. Paint removal, inspection, and repainting will require the construction of scaffolding or the employment of some other means to reach the top of the Tower. To most efficiently use this means of reaching the upper exterior reaches of the Tower, the paint of all exterior metal portions of the Tower should also be removed at this time and all metal parts thoroughly inspected for damage and documented. In addition, the roof of the Tower, composed of 3/32 sheet copper, and the ventilator ball at the top should be inspected from the outside for damage, and conditions documented. If the Park Service prefers to repair the existing gallery to make it safe for maintenance and inspection activities but not allow visitor access at this time, missing parts should be fabricated and installed, repair welding should be performed on cracks in exterior metal plating and ground smooth to achieve the proper exterior finish, and a new railing should be installed. If the National Park Service is determined to strengthen the exterior gallery to allow visitors access to it, design and contract documents should be drawn based on the verified conditions. It is likely that considerable fabrication and installation of new strengthening members will occur in this case, in addition to repair of existing deteriorated features and replacement of the exterior railing, which should be replaced in either case. The engineers designing the structural strengthening members and the contractors fabricating new parts and making repairs will want close access to the surfaces to field verify conditions found after paint removal and before new paint coats are applied. To maintain the existing presentation of the historic exterior, it is preferable to install a railing that matches the one installed by the Coast Guard in 1965. However, if visitor access is to be allowed in the future, the Park Service may opt to install one that meets current code requirements.

After paint removal, inspection of surfaces, and installation of needed repair materials, the metal and brick surfaces of the exterior of the Tower should be repainted using the historic color scheme that has been in use since at least 1945. This includes painting of the granite surfaces surrounding the windows, which were originally not painted, but have now been painted for nearly sixty years. It does not include painting the vertical surface of the base capstone which was inadvertently overpainted during the 1997 painting of the tower and should be returned to its historically unpainted condition. If
